UNDERWATER BRIDGE INSPECTION REPORT

STRUCTURE NO. 7065

GARDEN LAKE

DISTRICT 1 - LAKE COUNTY

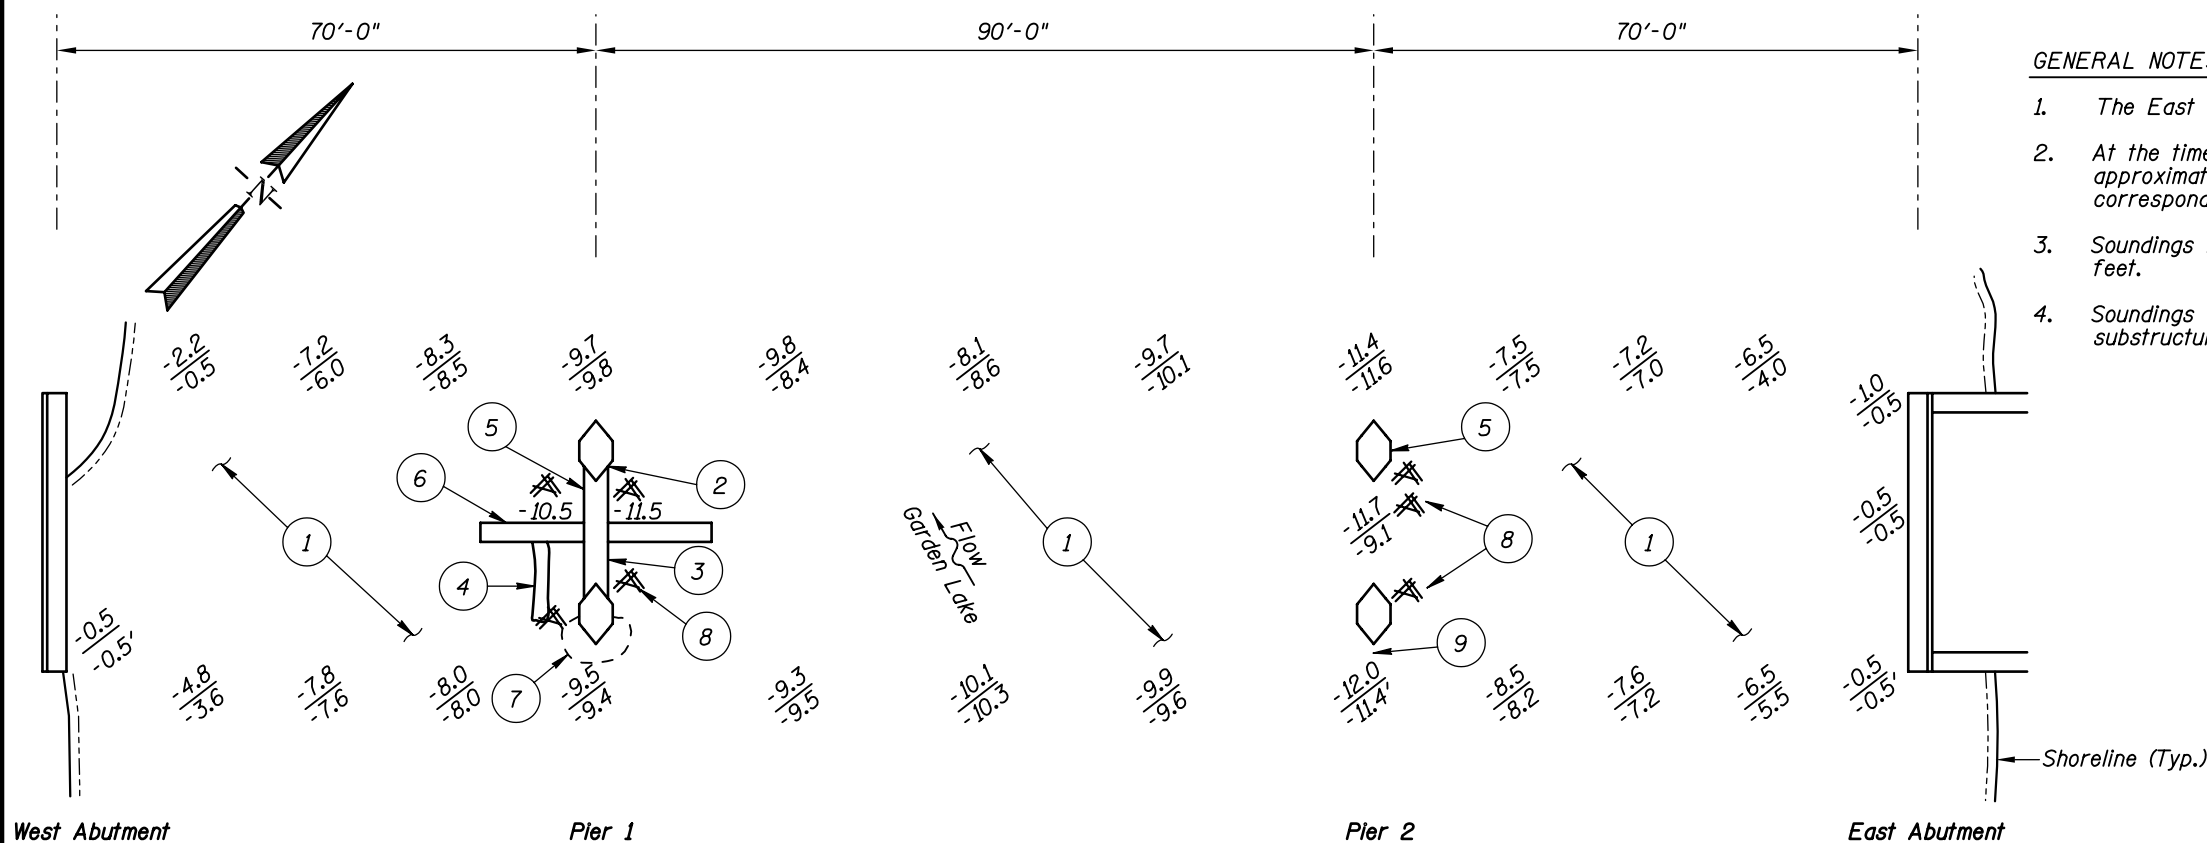
INSPECTION AND SOUNDING PLAN

| <p>① The channel bottom material consisted of sandy gravel with 2 inches of probe rod penetration and scattered 1- to 3-foot-diameter riprap and 6-inch-diameter cobbles.</p> <p>② Section loss, approximately 12 inches high by 6 inches wide, with 2 inches maximum penetration.</p> <p>③ The top of a horizontal strut was observed 5.5 feet below the waterline. The channel bottom was flush with the bottom of horizontal strut on the west side of the pier, and on the east side of the pier there was a 1 foot cavity below the bottom of the horizontal strut.</p> <p>④ 1-foot-diameter log was observed on the channel bottom extending along the upstream half of the pier.</p> <p>⑤ The concrete surfaces on both piers from 6 inches above the waterline to 3 feet below the waterline exhibited up to a 1/4 inch scaling, and somewhat soft surface concrete with random popouts.</p> <p>⑥ At approximately 8.0 feet below the waterline at the center of the horizontal strut of Pier 1 a steel I-beam was observed extending out 5 feet on each side of the strut.</p> <p>⑦ A minor scour depression, 5 feet in radius by 1 foot deep, was observed at the upstream nose.</p> | <p>⑧ 6-inch-diameter and smaller timber debris was observed scattered throughout the pier.</p> <p>⑨ Heavy concentration of riprap was observed at the upstream nose.</p> |

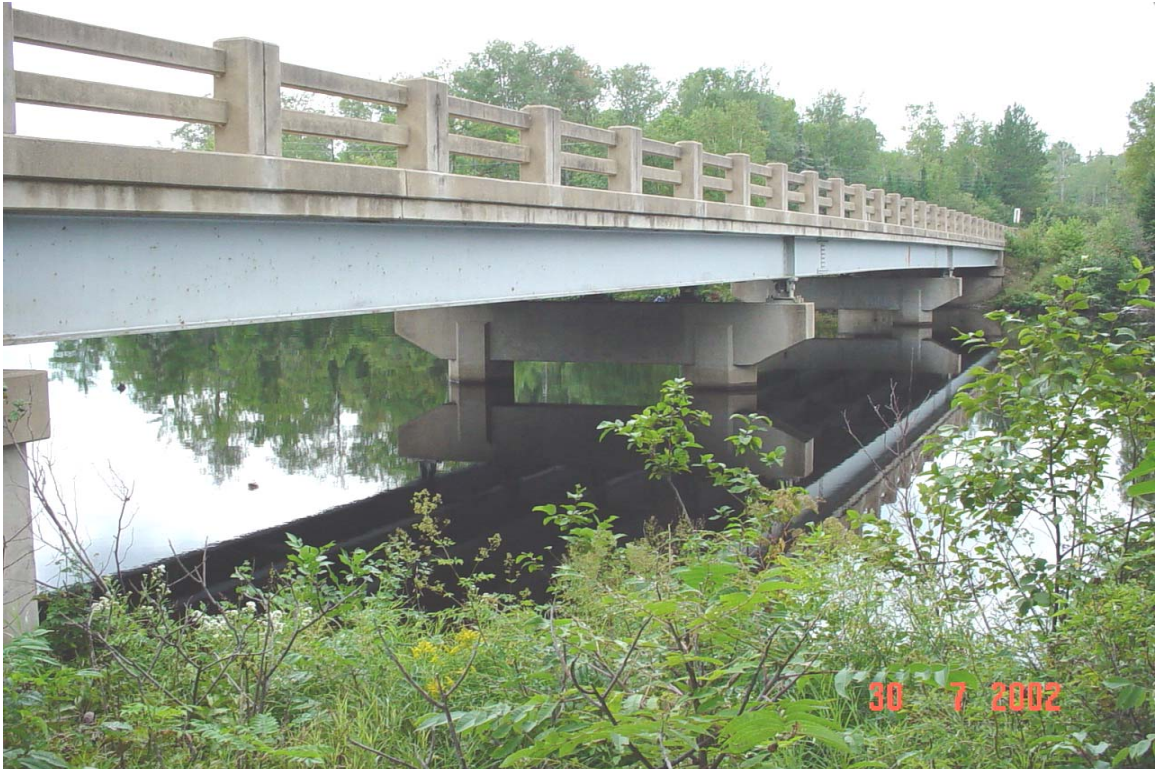
Photograph 1. Overall View of Structure, Looking South.

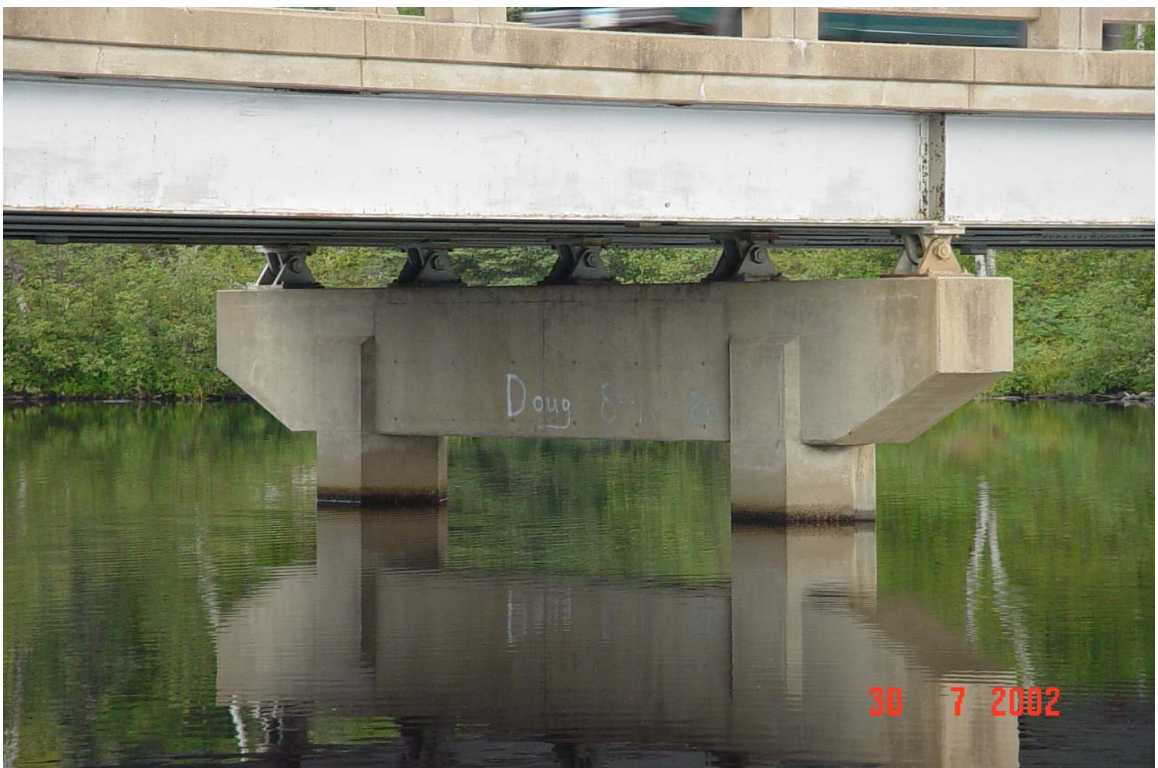
Photograph 2. Overall of Pier 1, Looking North.

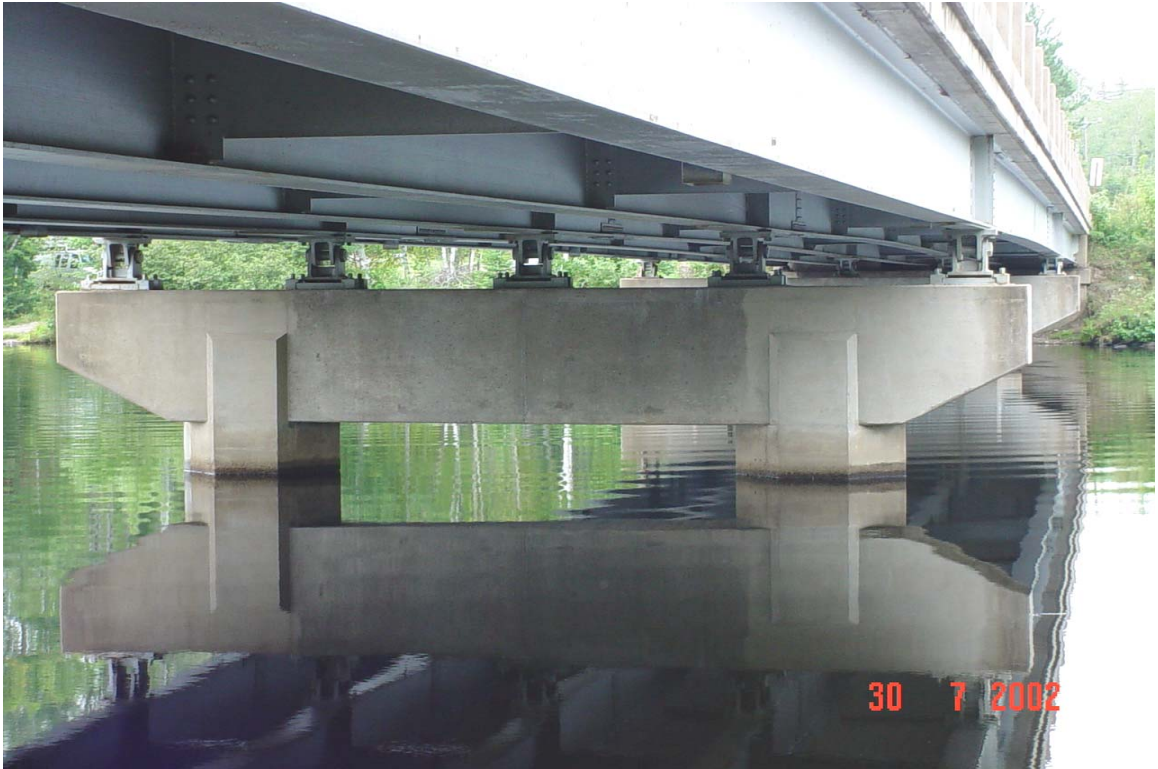
Photograph 3. View of Pier 2, Looking Southwest.

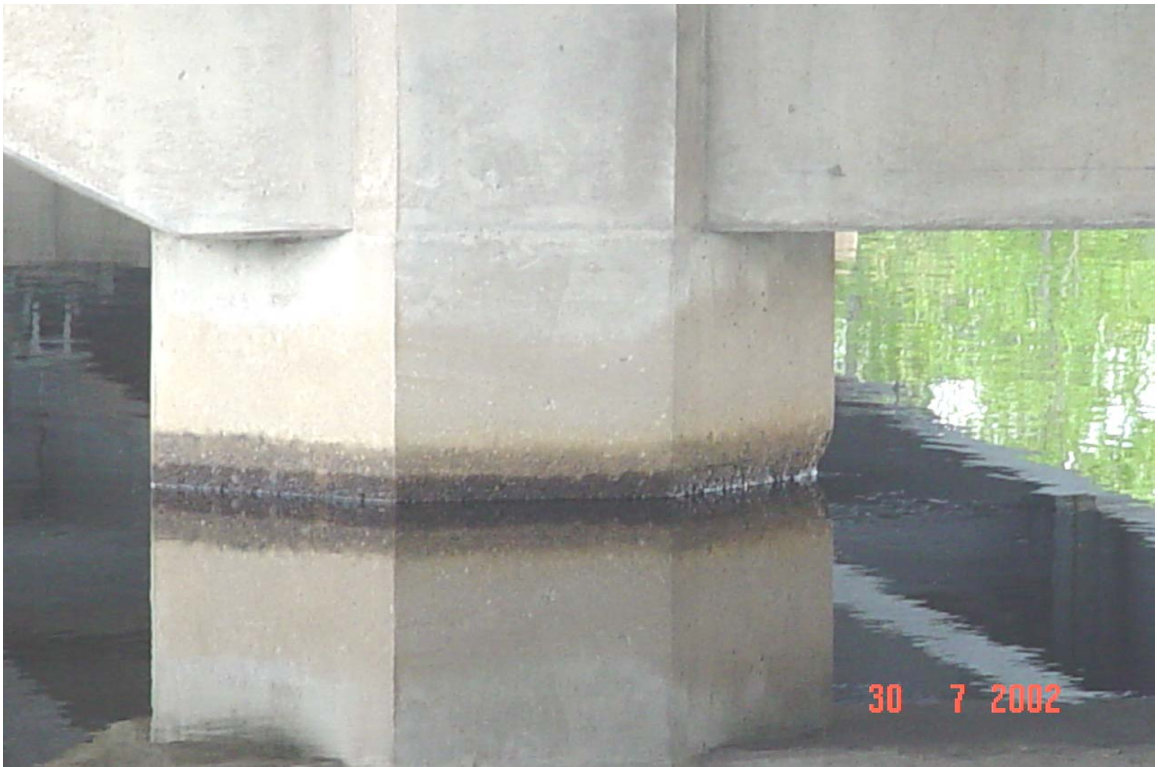
- (A) A minor area of section loss, 12 inches high by 6 inches wide, was located on the upstream nose of the North Shaft of Pier 1 with no exposed reinforcing steel.
- (B) The concrete surfaces on both piers from 6 inches above the waterline to 3 feet below the waterline exhibited up to a 1/4 inch deep scaling, and somewhat soft surface concrete with random popouts.
- (C) Minor accumulations of timber debris were observed on the channel bottom along both piers.
- (D) The top of the horizontal strut was observed at 5.5 feet below the waterline at Pier 1. The channel bottom was flush with the bottom of horizontal strut on the west side of the pier, and on the east side of the pier there was a 1-foot cavity below the bottom of the horizontal strut.
- (E) A minor scour depression, 5 foot in radius by 1 foot deep, was observed at the upstream nose of Pier 1.

Photograph 4. View of Downstream Shaft of Pier 1, Looking East.

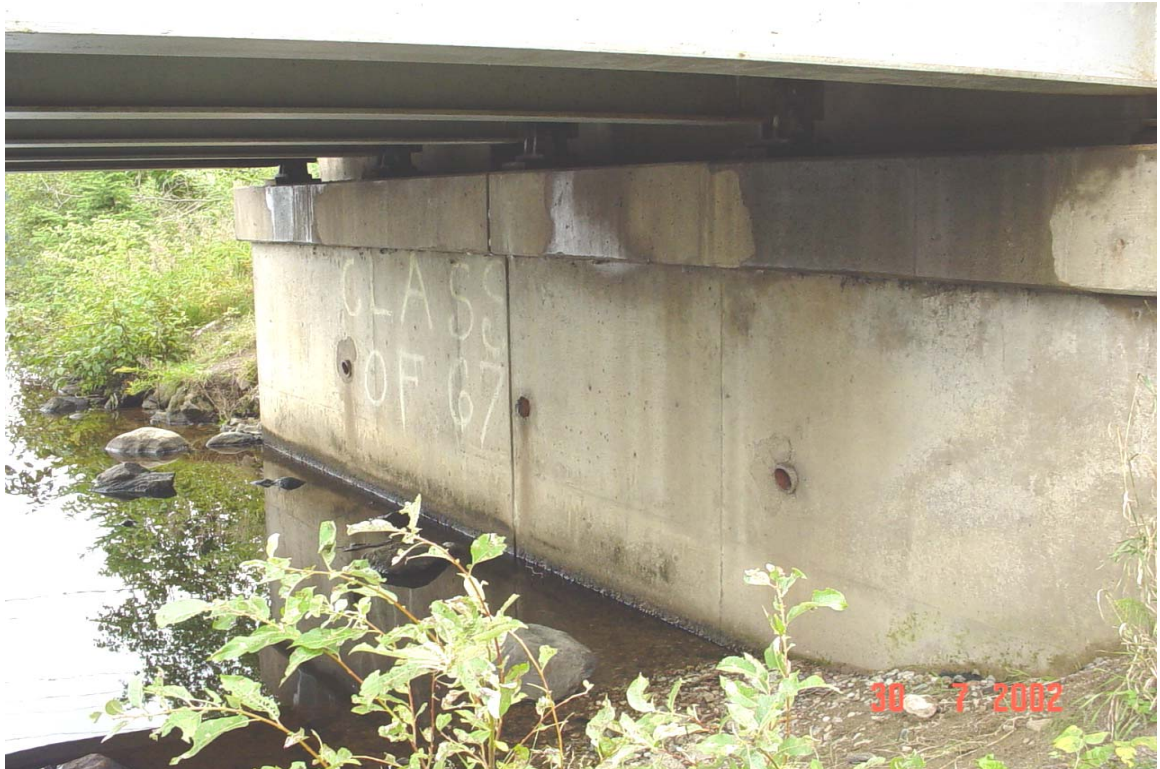
Photograph 5. View of West Abutment, Looking South.
